**Hardbottom and Cultural Resource Surveys of the Post 45 Charleston Harbor
Project Study Area, Charleston, South Carolina**

Submitted to:
United States Army Corps of Engineers
Charleston, SC District
January 2013

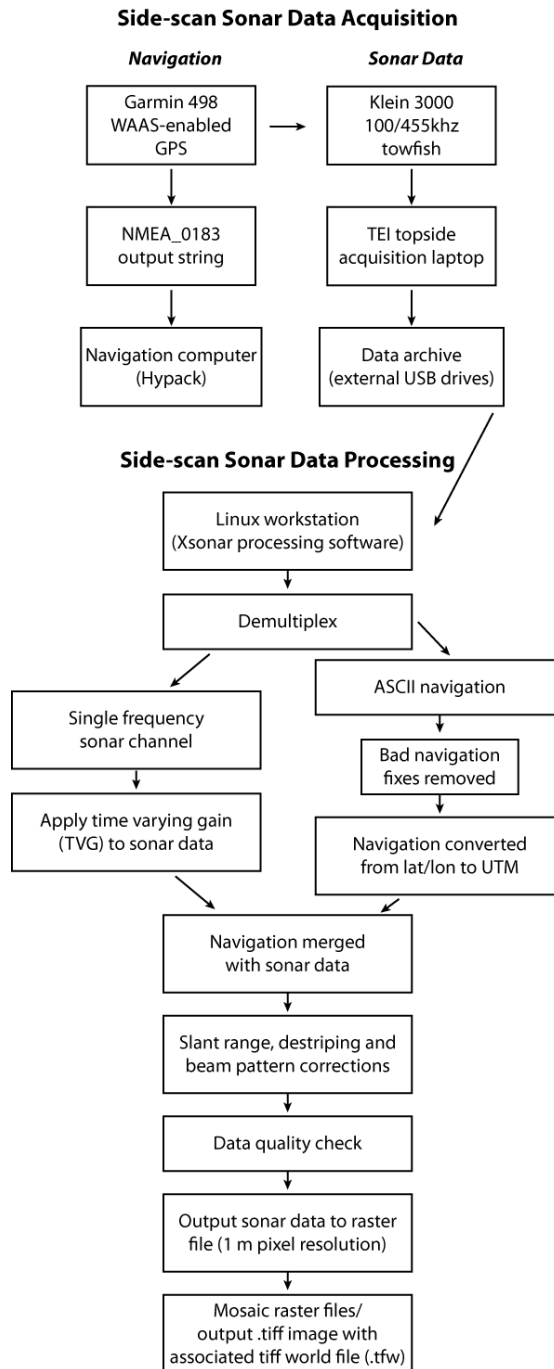
Figure 3. Side scan sonar data acquisition and processing workflow.

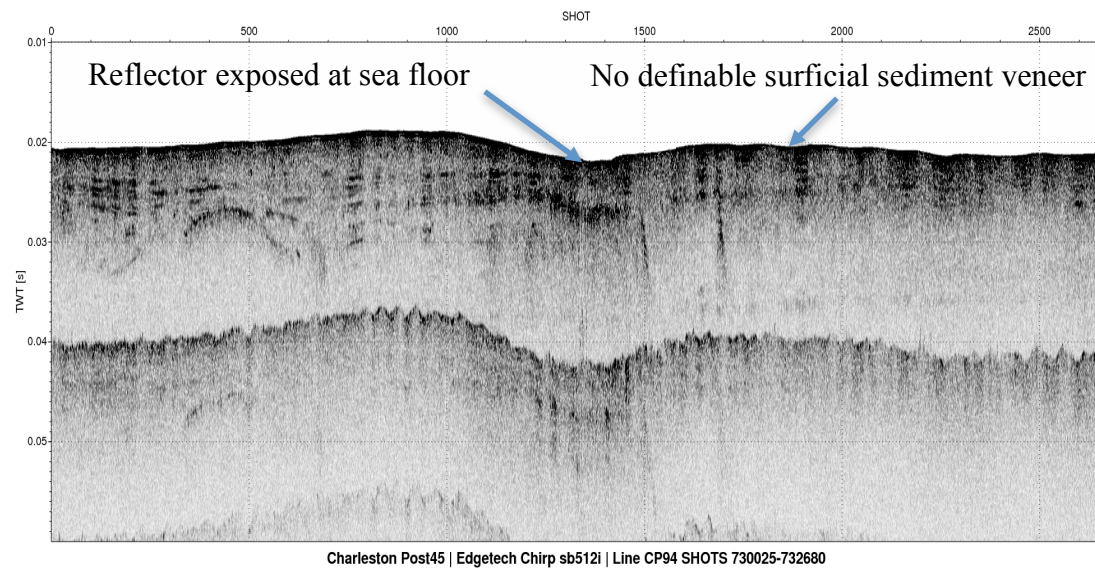
Figure 10. Sub-bottom profile (Line 94) showing examples where older, tilted reflectors are evident at or near the sea floor with little or no overlying surficial sediment cover. Hard ground habitats are highly likely to be found in such areas.

2. Areas showing very limited or no significant surficial sediment veneer were defined as probable hard ground areas based on chirp data alone (figure 12). In areas where there is clear evidence of strong inclined reflectors truncated at or very near the sea floor there is high confidence that hard ground habitat will be found in the area; particularly where such reflectors may extend through and stand in relief above the surrounding sea floor. In other areas where sediment cover is very thin or near the resolution of the system there is greater uncertainty in whether hard grounds may be present. These areas were classified as “possible hard ground” areas.

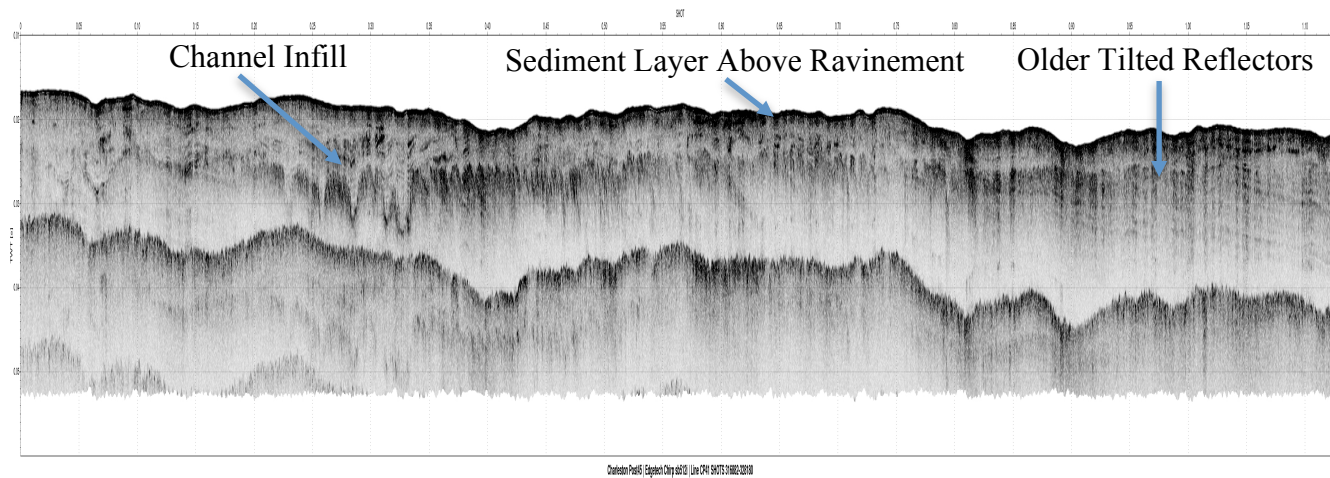
Figure 11. Sub-bottom profile (Line 41) showing examples where a definable thickness (>4 meters) of sediment infilling within a definable and laterally continuous channel and above a flat lying ravinement surface. In such areas older, tilted and potentially indurated substrate that could form hard grounds is separated from the sea floor and presence of hard grounds is highly unlikely.
